# Wienerberger Technical Guidance

## LIME BLOWING

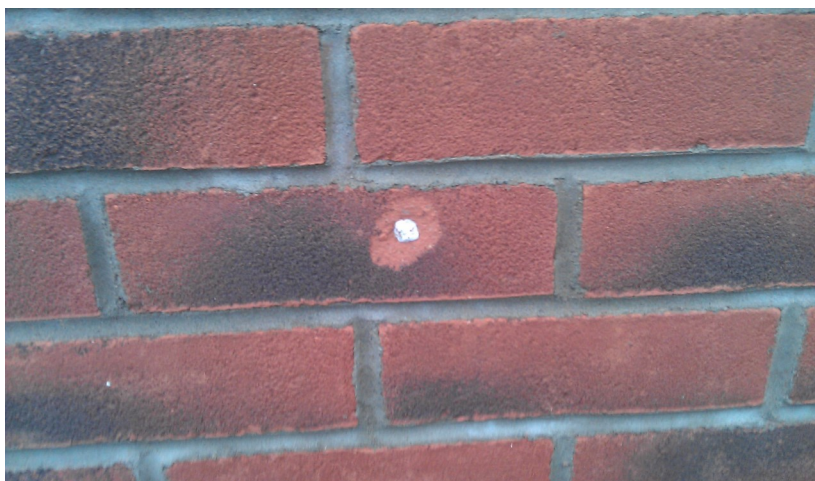
They originate from the presence of calcium carbonate particles (frequently fossil fragments) in some brick-making clays. These particles decompose during the firing process and form quicklime. Occasionally larger particles (>1mm) are retained within the process and expand when coming into contact with water, forming calcium hydroxide.

Pitting of the surface can occur when remaining lime particles are sufficiently wetted causing expansion. For particles deep inside the brick, the pressure generated by this expansion is not sufficient to cause any damage. When close to the surface however, the resultant stresses lead to the outer face being disturbed. A small sliver of the brick surface may be dislodged exposing the lime particle below.

Lime blowing is not progressive and once the particle of lime has become wet and 'blown', the remaining brick structure is completely stable. Lime blowing is not progressive and is typically found to reach its peak shortly after it is first observed. The white particles weather down fairly quickly and become a visually acceptable part of the structure.

Unless the lime blows exceed 2mm in size when viewed at a distance of 3m, it is advised that they are left alone – from experience, any remedial treatment on small lime blows does not improve the cosmetic appearance of the brickwork.

In severe or highly conspicuous instances, remedial treatment may be carried out by tinting over the holes with a matching pigment (see 'Tinting of Brickwork' for more information). For larger lime blows, the material can be drilled out and repaired with a filling medium. The entire brick, including the repaired blow, is then tinted to match the adjacent brickwork.
