# Wienerberger Technical Guidance

## LIME BLOWING

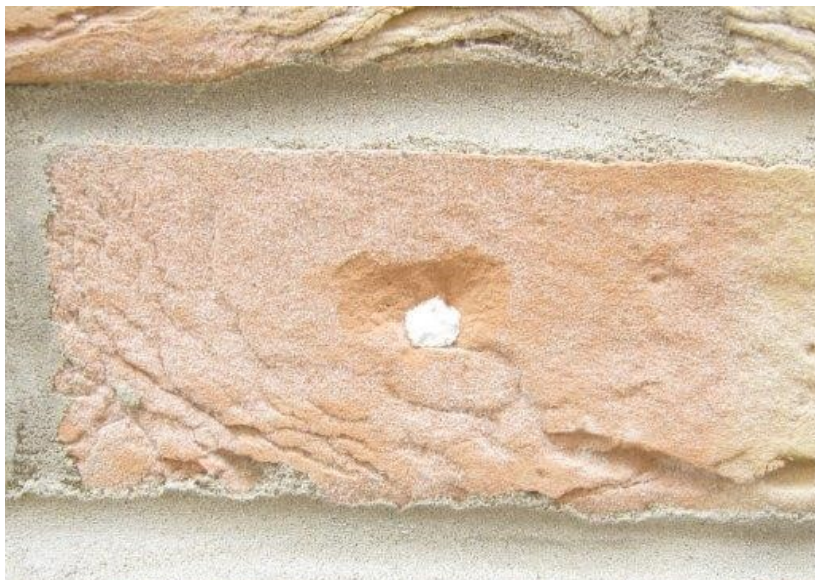
Pitting of the surface can occur when remaining lime particles are sufficiently wetted causing expansion. For particles deep inside the brick, the pressure generated by this expansion is not sufficient to cause any damage. When close to the surface however, the resultant stresses lead to the outer face being disturbed. A small sliver of the brick surface may be dislodged exposing the lime particle below.

Lime blowing is not progressive and once the particle of lime has become wet and 'blown', the remaining brick structure is completely stable. Lime blowing is not progressive and is typically found to reach its peak shortly after it is first observed. The white particles weather down fairly quickly and become a visually acceptable part of the structure.

Unless the lime blows exceed 2mm in size when viewed at a distance of 3m, it is advised that they are left alone – from experience, any remedial treatment on small lime blows does not improve the cosmetic appearance of the brickwork.

In severe or highly conspicuous instances, remedial treatment may be carried out by tinting over the holes with a matching pigment (see 'Tinting of Brickwork' for more information). For larger lime blows, the material can be drilled out and repaired with a filling medium. The entire brick, including the repaired blow, is then tinted to match the adjacent brickwork.
