# Wienerberger Technical Guidance

## METALLIC STAINING

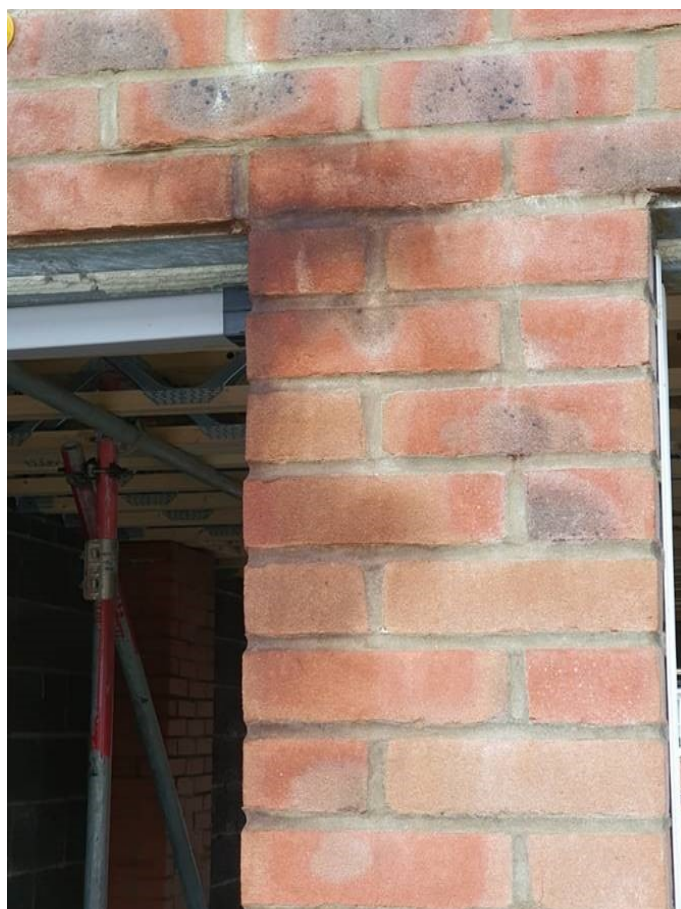
Iron staining usually appears as a stain to the brick face or mortar joint. The staining can come from metal embedded in the structure, or it can be derived from the brick if made with clays with high iron content, or from the mortar sand.

Iron staining occurs due to salt migration when compounds of iron (trace elements within the raw material) are drawn from within the body of the brick and deposited on the surface as a result of moisture movement. Here they will oxidise and produce a stain similar to rust.

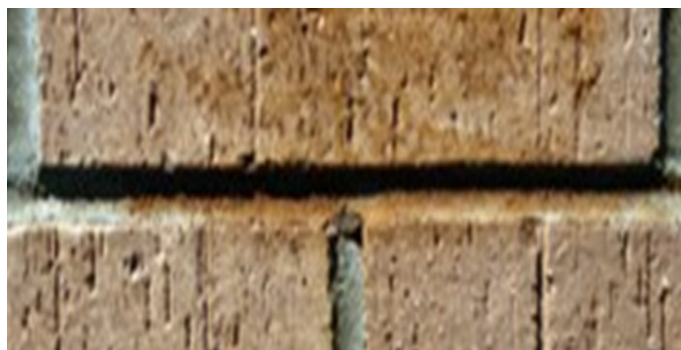
Manganese staining manifests itself as a dark brown or black stain concentrated along mortar joints. It is caused by manganese dioxide (used as a colouring agent during manufacturing) that has dissolved in rainwater, construction water or muriatic acid.

During the brick firing process, the manganese colouring agents undergo several chemical changes, resulting in manganese compounds that are insoluble in water. They have varying degrees of solubility in weak acids. Once dissolved, these compounds may migrate in solution toward the surface of the brickwork.

Manganese staining is closely related to efflorescence since it is the sulphate and chloride salts of manganese that travel to the surface of the brickwork. When the solution reaches the mortar joints, the salts are neutralised by the cement or lime in the mortar, producing insoluble manganese hydroxide. The manganese hydroxide precipitate is deposited on the mortar joint and when dry, converts to brown manganese tetroxide resulting in the stain.

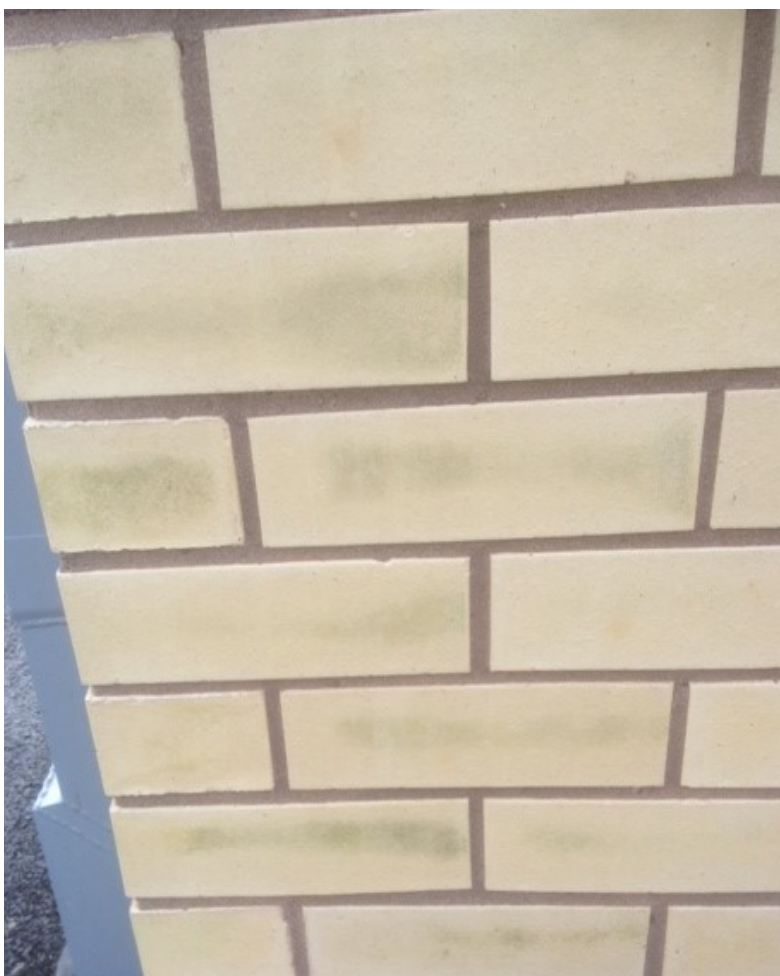
Like most soluble salts it requires saturation to bring it to the surface, where it appears as a yellowish stain that may change to a green or even light brown colour.

Vanadium does not come and go in the same manner as a white efflorescence, and should really be described as a true stain.
